Intel[®] Mobile Pentium[®] II Processor Specification Update

Release Date: December 2000

Order Number: 243887-027

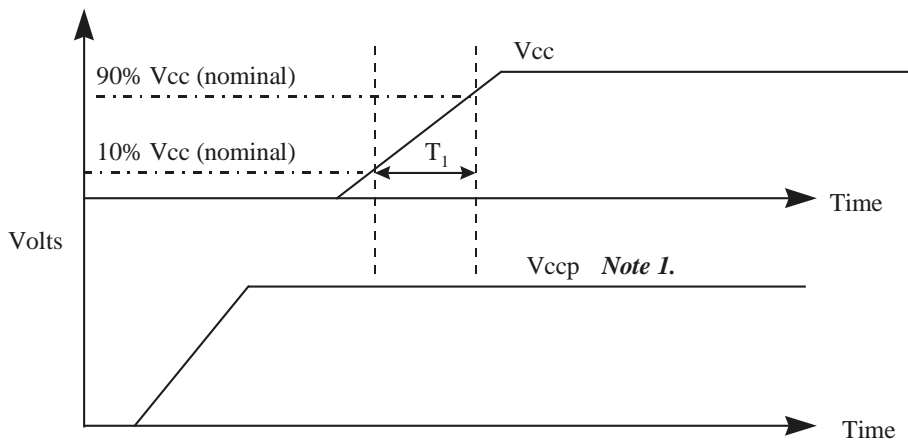
Figure 1. V_{CC}/V_{CCP} Timing Requirements (Mobile)

Problem: The processor uses the PWRGOOD signal to ensure that no voltage sequencing issues arise; no pin assertions should cause the processor to change its behavior until this signal is asserted, when all power supplies and clocks to the processor are valid and stable. However, if V_{CC} ramps up before V_{CCP} , it will cause the processor to enter an invalid state.

Implication: If this erratum occurs, the system may boot normally however, the L2 cache may not be initialized.

Workaround: For Mobile Pentium II processors, ensure that V_{CC} ramps after or with the L2 cache IO voltage (V_{CCP}). If V_{CCP} ramps after the V_{CC} , a delay circuit can be placed on the core V_{CC} to ensure that V_{CC} ramps at the same time or after V_{CCP} as shown below in Figure 1.

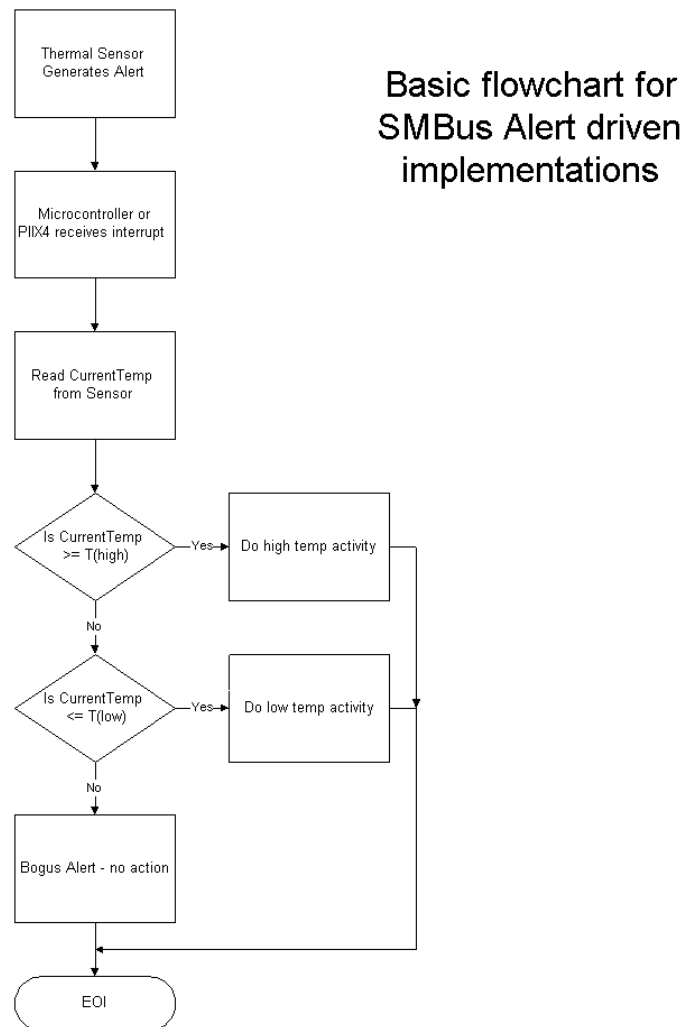
Figure 2. Workaround Flowchart: SMBALERT#-Driven System

Under the conditions described below, the thermal sensor incorrectly generates the SMBALERT# interrupt. All of the following conditions must be met to trigger a false interrupt:

1. Before servicing an interrupt from the thermal sensor, read and compare the processor thermal reading with the threshold limits (T_{HIGH} or T_{LOW}). Figures 2 and 3 provide basic flowcharts for the implementation of this workaround in an interrupt driven system.
2. If the firmware implemented polls the Status Register only, then before taking any action, re-read the temperature register and do a comparison with the alarm threshold limits (T_{HIGH} or T_{LOW}) to determine if the value is actually still within the temperature window.

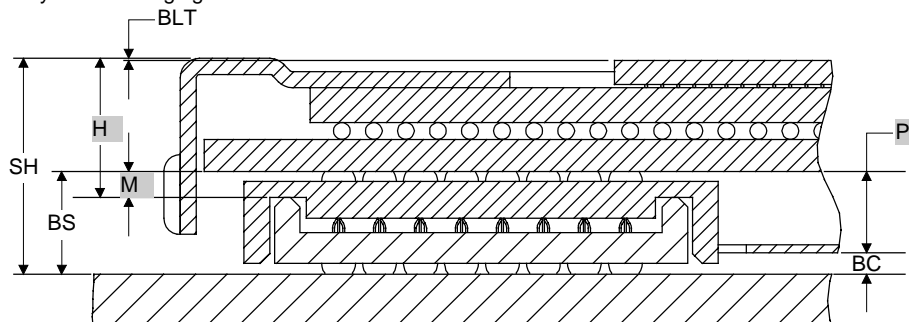
Figure 5.6. Cross Sectional View with Vertical Dimensions

B1. Mislabeled Vertical Dimension Parameters

Figure 5.6 in the *Mobile Pentium® II Processor at 233 MHz, 266 MHz, and 300 MHz* datasheet should be replaced by the following figure:

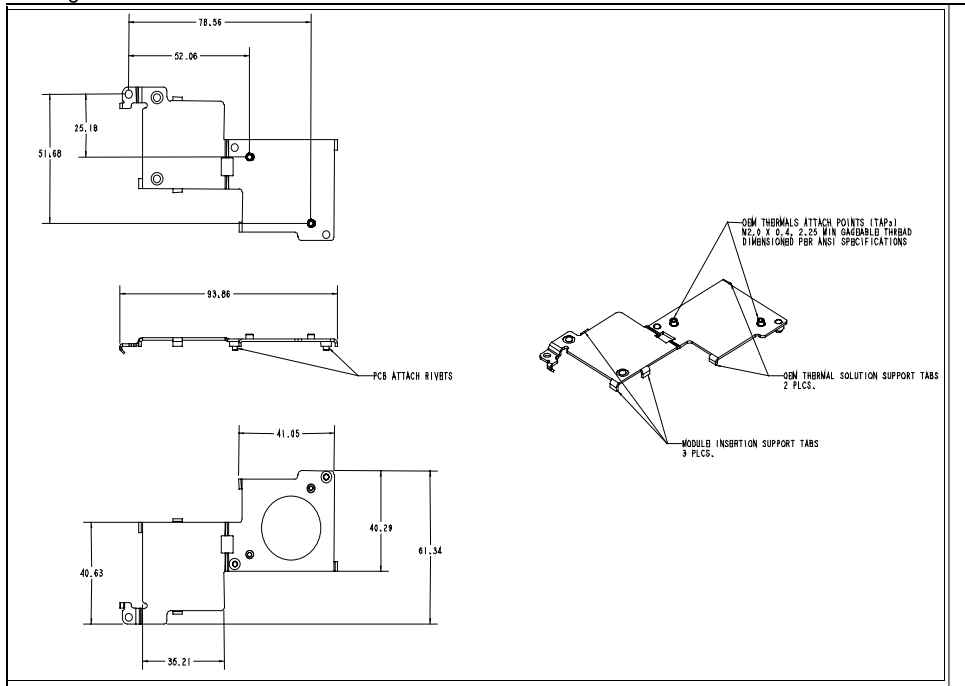
Figure 1. TAP Gageable Thread Clarification

OEM Thermal Attach Points (TAPs) M2.0 x 0.4, 2.25 min gageable thread dimensioned per ANSI specification.
